**Deformation of River-bed and Its Causes in the Recent Quarter Century
in the Lam Phachi River Basin**

Abstract

Keywords: bank erosion, bend cutoff, terrace deformation, lateral migration

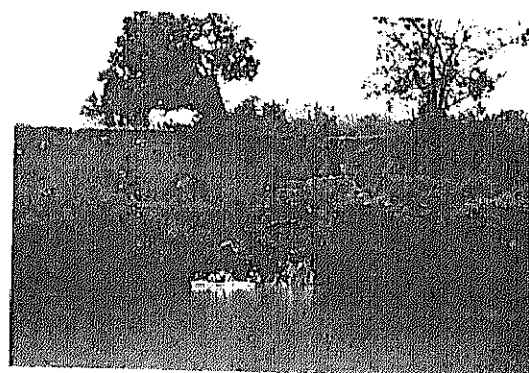
On the cliff the cultivated field of cassava, for example, extends until the edge of the cliff. As rainwater gathers between ridges and falls on the cliff, vertical erosion is accelerated resulting in a particular shape just like the teeth of a comb (Photo 1). Photo 2 shows the eroded steep cliff at the right bank located at a distance of about 1 km upstream from the river mouth. The cliff reaches almost 12 m in terms of relative height. The site at which bank erosion occurred is observed where the stream bends, in addition to the cultivated fields extending up to the bank edge.

Photo 2 Bank erosion near the 1 km point

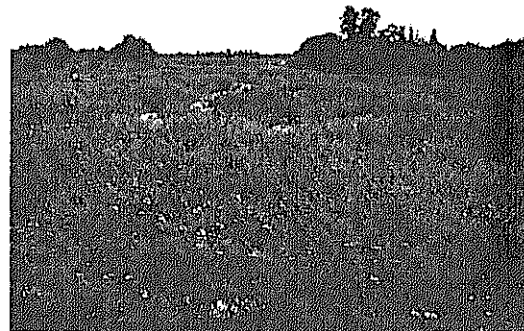
Photo 4 Vegetation cover on river-bed
