# SCIENTIFIC REPORTS

## Internal structure of cesium-bearing radioactive microparticles released from Fukushima nuclear power plant

Noriko Yamaguchi<sup>1,\*</sup>, Masanori Mitome<sup>2</sup>, Akiyama-Hasegawa Kotone<sup>2</sup>, Maki Asano<sup>1,3</sup>, Kouji Adachi<sup>4</sup> & Toshihiro Kogure<sup>5,\*</sup>

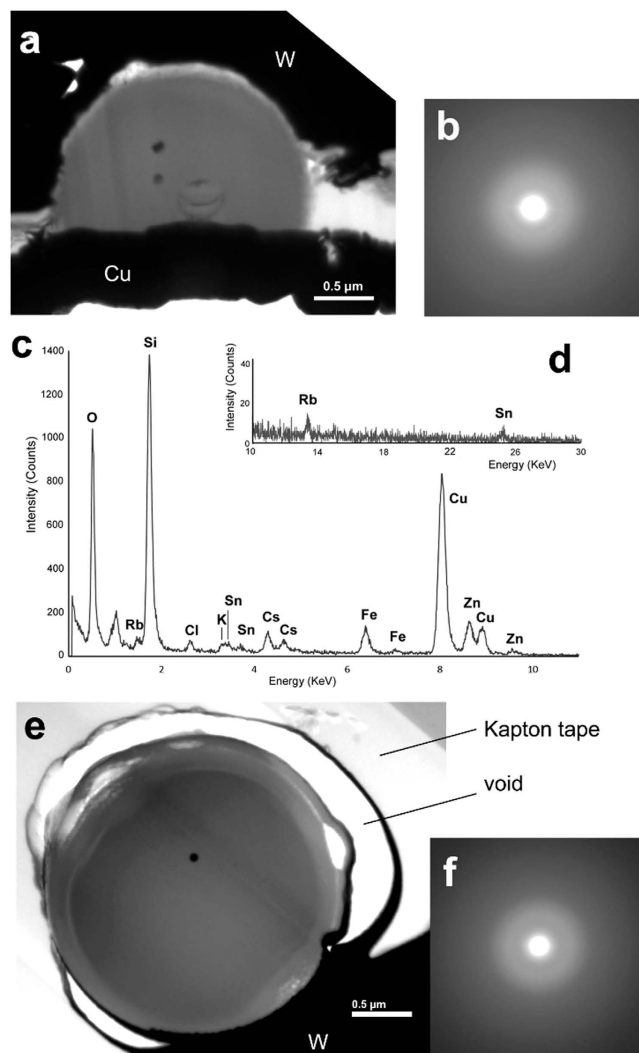
**Figure 1.** (a) Bright-field (BF) image of NWC-1. The opaque material outside the microparticle is tungsten (W) and copper (Cu) deposited in the FIB process. (b) Electron diffraction (ED) pattern from the particle. (c,d) EDS spectrum acquired from almost the whole area of the particle for the energy range of (c) 0–11 keV and (d) 10–30 keV. (e) BF image of CB-8. The opaque material outside the sphere is W and the thin transparent material is Kapton tape. (f) ED pattern from the particle.

Bright-field (BF) images and selected-area electron diffraction (SAED) patterns recorded in TEM from the whole area of NWC-1 and CB-8 are shown in Fig. 1, along with the energy-dispersive X-ray spectrum (EDS) acquired in TEM from NWC-1. Preparation of thin specimens from NWC-1 microparticle by focused-ion-beam (FIB) process was successful only for the upper half of the sphere. The BF contrast of NWC-1 (Fig. 1a) was almost uniform except for two dark nanoparticles inside the sphere. These nanoparticles will be described in a later subsection. The SAED pattern from the whole particle consists of only a halo (Fig. 1b) and the EDS from the whole

particle (Fig. 1c,d) mainly consist of peaks of Si and O (Cu is from the supporting mesh), indicating that the particle was basically silicate glass. Additionally, Cl, K, Cs, Fe, Zn, Rb, and Sn were definitely identified. The presence of Na was not confirmed since its peak overlapped with the L-peak of Zn. These elements were previously reported<sup>7,8</sup> except for K. EDS Semi-quantitative analysis for almost the entire area of the TEM specimen, without considering the absorption effect estimated the glass composition (wt.%) to be SiO<sub>2</sub>; 69.3, K<sub>2</sub>O; 1.9, Fe<sub>2</sub>O<sub>3</sub>; 8.6, ZnO; 11.0, Rb<sub>2</sub>O; 1.3, SnO<sub>2</sub>; 1.4, Cs<sub>2</sub>O; 3.4 with a small amount of Cl (1.4 wt.%). The valence states of cations were assumed to be in line with results in an X-ray absorption spectroscopic study<sup>8</sup>. Rubidium, Cs and Sn are the fission products of U-235. Tin is also used for fuel cladding<sup>11</sup>. Iron is used as steel for reactor pressure vessels, and Si and O are main components of concrete at the bottom of the containment vessel, where the melt-down fuel or core debris is thought to exist. Zinc had been added to the primary cooling water<sup>12</sup>. Potassium and Cl may originate from concrete and/or seawater, which was used to cool down the reactor.

The BF TEM image of CB-8 showed a two-layer structure having an inner core with darker contrast, an outer crust with a lighter one, and a small dark nanoparticle near the center (Fig. 1e). The thickness of the crust was around 0.2 μm. SAED pattern indicated that both are amorphous (Fig. 1f). Locally, a bubble-like structure was observed at a certain radius in the crust, or the outside part was peeled off at the radius (Fig. 1e). The chemical composition of the entire area of the specimen was SiO<sub>2</sub>; 73.3, K<sub>2</sub>O; 1.4, Fe<sub>2</sub>O<sub>3</sub>; 7.2, ZnO; 11.4, Rb<sub>2</sub>O; 1.2, SnO<sub>2</sub>; 1.5, Cs<sub>2</sub>O; 3.3 and Cl; 0.7, which is similar to that of NWC-1.

**Crystalline nanoparticles in the glass.** Two nanoparticles with dark contrast were observed in the TEM image of NWC-1 (Fig. 1a). Although EDS spectrum only from the particles cannot be obtained since they are still buried in the glass in spite of the thinning by FIB, S was distinctively identified from the particles (Fig. 3a). Elemental mapping by STEM-EDS indicated enrichment of Cu, Zn and Mo at the nanoparticles along with S, indicating that they are sulfide. The possibility of sulfate was excluded because oxygen is deficient in the nanoparticles in the oxygen map (Fig. 3a). Moreover, the locations of Cu, Zn and Mo do not overlap within the nanoparticles, suggesting that these metal elements form different sulfide phases in the nanoparticle (Fig. 3a). SAED from the left particle showed a single-crystal diffraction pattern (Fig. 3b), which can be explained by the crystallographic parameters for a high-temperature polymorph of digenite (Cu<sub>2-x</sub>S). The origin of Cu and S may be minor elements in the concrete. On the other hand, Ag and Te were distinctively detected by EDS in TEM from the nanoparticle in CB-8 (Supplementary Fig. S3 online), indicating the particle to be silver telluride. Both elements can be fission products of U. Diffraction spots were observed in the SAED pattern from the particle, indicating that it is crystalline but the phase could not be identified. These sulfide and telluride were probably segregated and crystallized in the microparticles at the molten state.

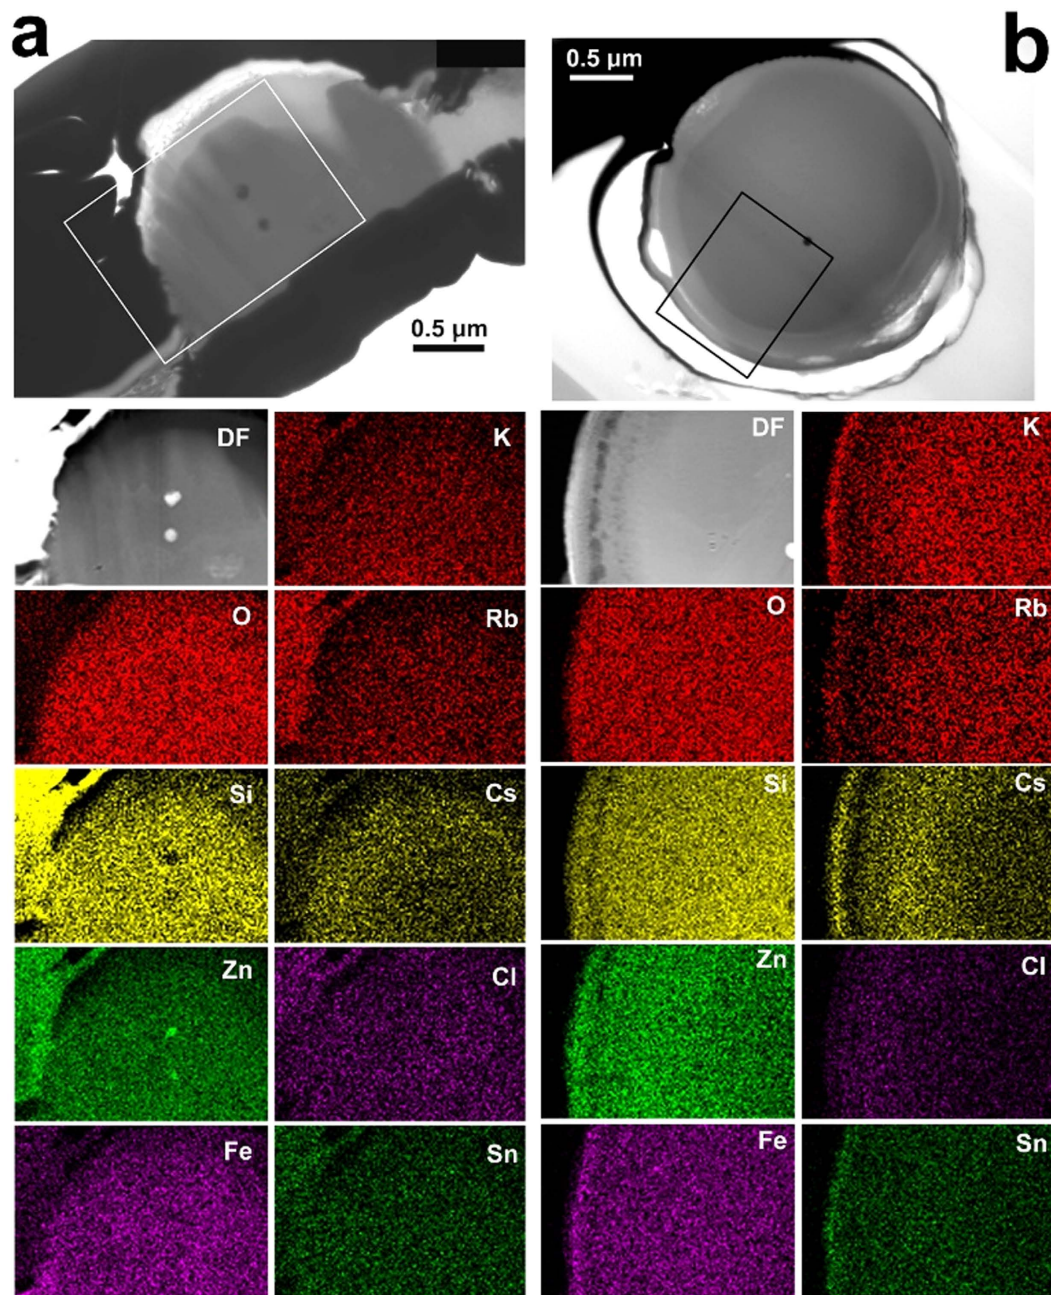
**Figure 2.** (a) Element maps of NWC-1 acquired by STEM-EDS with a STEM Dark-field (DF) image at the same area, and (top) TEM Bright-field image in which the rectangle indicates the area analyzed by STEM-EDS. The thin area around the top of the particle which was not observed in Fig. 1a was formed by a further thinning process by FIB. (b) Element maps and images of CB-8 with the same framing as in (a).

**Distributions of elements in microparticles.** Elemental maps from NWC-1 using STEM-EDS are shown in Fig. 2a. Brighter color indicates higher concentration of the elements. All elements were almost uniformly distributed in the particle with Cs the only exception. Cesium concentration was lower near the center than the outside of the particle. The ratio of the amounts between the center and outside is around two. It is possible that vapor-phase cesium in the reactor was absorbed to the molten silicate microparticles, from their surface. The low diffusion velocity of cesium in the glass may have left the concentration gradient. On the contrary, elemental mapping for CB-8 (Fig. 2b) indicates that K, Rb and Cs were distinctively depleted in the crust but concentrated in the vicinity of the surface. Although the reason for the high concentration at the surface is not certain, it might be an artifact by diffusion of alkali cations caused by electron-beam radiation in the analysis. Chlorine was concentrated in the crust.

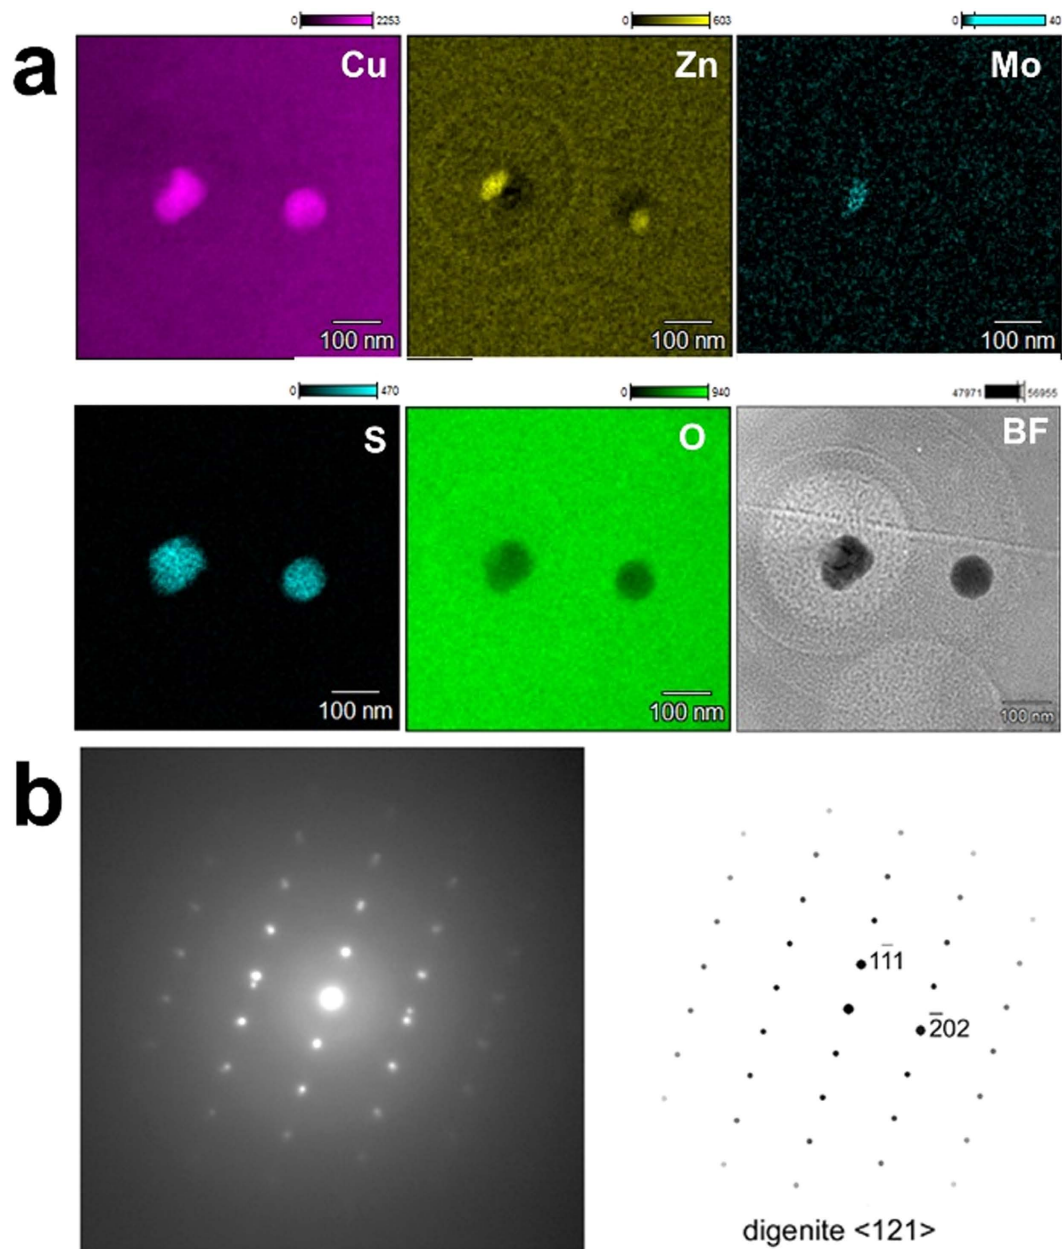
**Figure 3.** (a) Element maps and STEM bright-field (BF) image of the two nanoparticles inside NWC-1. The circular contrasts outside the nanoparticles in the BF image are radiation damage in glass formed by the electron probe for chemical analyses. (b) (Left) ED pattern from the left nanoparticle. (Right) Drawing of ED pattern for the high-temperature polymorph of digenite ( $\text{Cu}_{2-x}\text{S}$ ) along  $\langle 121 \rangle$ .
