# DIGITAL NON-METRIC IMAGE-BASED DOCUMENTATION FOR THE PRESERVATION AND RESTORATION OF MURAL PAINTINGS: THE CASE OF THE ÜZÜMLÜ ROCK-HEWN CHURCH, TURKEY

## Abstract:

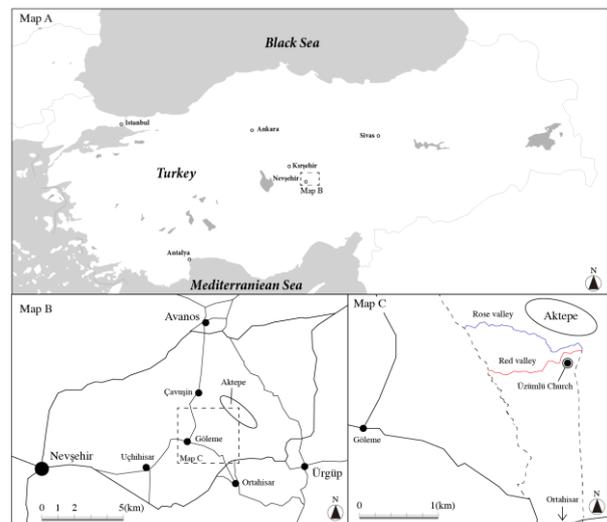
Figure 2: Map of Turkey (A) and the study site (B & C).

On the southern side of Aktepe, which is a rock mountain in the northern part of Cappadocia, are two tourist routes from Ortahisar Village: Red Valley and Rose Valley. The rock-hewn church of Üzümlü (üzümlü is Turkish for 'grape') is located west of the middle cross-point of Red Valley and Rose Valley (Fig. 2). We chose this church as our first target for the preservation and restoration of mural paintings in rock-hewn churches because it exhibits typical Cappadocian deterioration caused by environmental factors, rock composition, seismic activity, and biological and human activities, including vandalism.

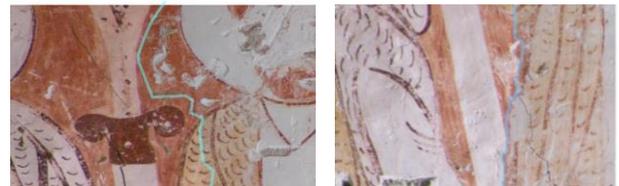
Figure 8: Photomerge examples: a) Successful implementation; b) failed photo combination.

3) Check the edge of each of the images (Fig. 8): Upon correct execution of the preceding steps, we checked each end of the reading photographs. If it was wrong, morphed images would not fit each other (such as in Fig 8b). Lack of overlapping images usually induced this error.

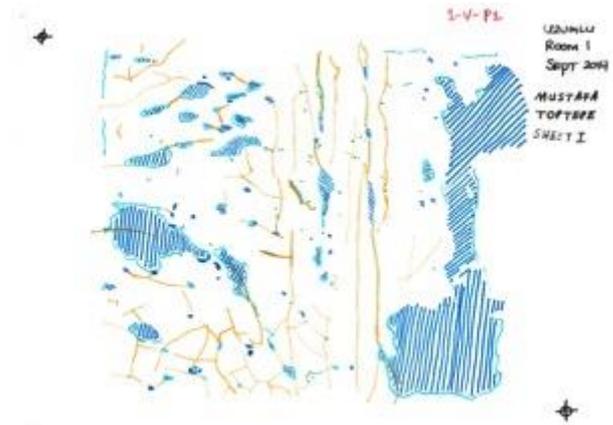
**Figure 16:** Scanned OHP sheet of plaster deterioration on the ceiling in narthex.

After the state of layer deterioration was documented, an OHP sheet was scanned to create a digital mural condition sheet (Fig. 16). In cases where the number of items was too large for these to be recorded on an OHP sheet, we used more than two OHP sheets to document one layer. Using Adobe Illustrator, we traced the scanned data with a pen tool. The traced deterioration sites were divided into different layers according to each item of deterioration. Therefore, each mural condition sheet can show the deterioration sites of selected items when a pdf file is created and viewed via pdf viewer software. The approximate scale of the mural condition sheets was then adjusted to 1/10, 1/15, 1/20 and 1/25. As we checked the deterioration of each layer of the mural paintings, we produced 39 mural condition sheets and 13 image mosaics of the mural paintings for the digital heritage inventories. An example is Fig. 17, which shows the paint layer deterioration of the ceiling in nave. All the digital inventories of the printed versions (Taniguchi 2015) that we created are available for viewing in Appendix 3 at the following webpage address: [http://rcwasia.hass.tsukuba.ac.jp/kaken/contents/content%20images/0\\_20150723\\_uzumlu\\_2014\\_final\\_s.pdf](http://rcwasia.hass.tsukuba.ac.jp/kaken/contents/content%20images/0_20150723_uzumlu_2014_final_s.pdf).
