Investigation on the Monitoring of Brick Structure in Yokosuka City

ABSTRACT

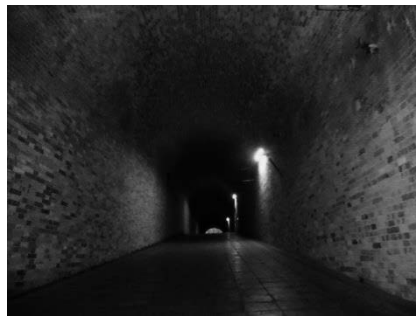
Figure 1: Brick structure in Sarushima

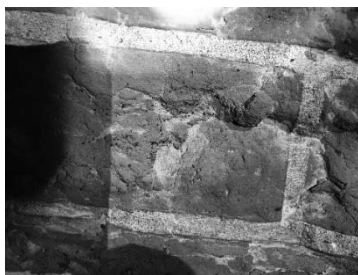
show the changes of brick masonry in Japan. However, many brick structures in Sarushima suffer from surface deterioration; for example, salt weathering (Figure 2). Salt weathering brings about collapse of bricks. One of the drivers that cause salt weathering is environment in brick structures.

Figure 2: Salt weathering

Results of XRD, Calcite (CaCO_3) was detected from brick debris at d3 spot, and Gypsum ($\text{CaCO}_4 \cdot 2\text{H}_2\text{O}$) was detected from brick debris at f1-2, and f1-3 spot. Both Calcite and Gypsum are poor solubility, and it is reported that these salts tend to form and separate in a high relative humidity environment. Moreover, it is reported that collapse of bricks is caused when humidity rises again, then salts in bricks deliquesce, because salts on the surface of bricks become heavy by absorbing moisture in the air, and it cause collapse of bricks. Therefore, amount of collapsed brick has increased even if Sarushima in July. Salt weathering is one of the drivers that induce the collapse of bricks, but amount in the f1-2 spot was larger than f1-3 spot despite Gypsum has been detected in f1-2 spot as well as f1-3 spot, thus it will be considered that the influence of vibration by tourists and the wind is other driver cause the collapse of bricks.
