Investigation for Degraded Stone Pillar Bases of the East Cocoon Warehouse of the Tomioka Silk Mill By X-Ray Diffraction Analysis

Yishan ZHOU¹, Ana ROMERO¹, Toshiya MATSUI¹, Masae OKANO²
¹ University of Tsukuba,
² Tomioka Silk Mill

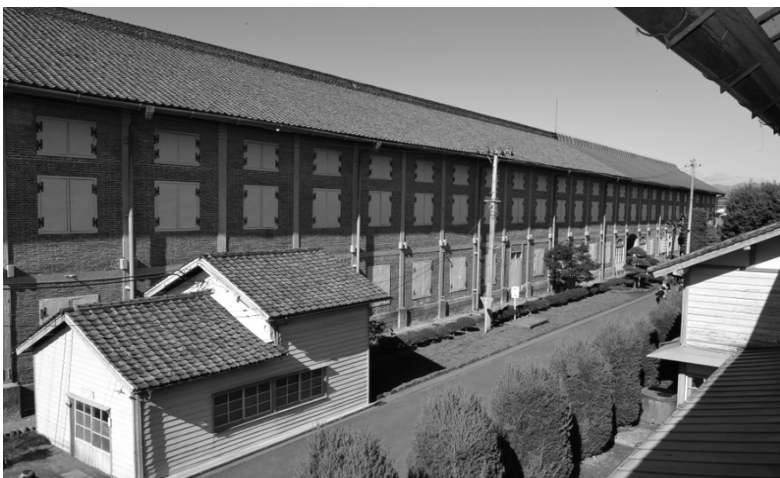
Figure 1: The East Cocoon Warehouse of the Tomioka Silk Mill

Along with converting from industrial spaces into public spaces, degradations of constitutions of the Tomioka Silk Mill (e.g., bricks, timber frames, stone pillar bases) have been observed. In the East Cocoon Warehouse, which is utilised as exhibition space in recent years, salt precipitations and powdering phenomenon on the surface of stone pillar bases is threatening the long-term preservation of the historic building itself. In order to figure out the relevant factors that have induced these degradations, and develop a suitable conservation method, surface precipitations and powders of 88 stone pillar bases of the East Cocoon Warehouse have been collected and investigated (Including 60 of the exterior eastern and western sides, 4 of the exterior northern and southern sides, 24 in interior space).

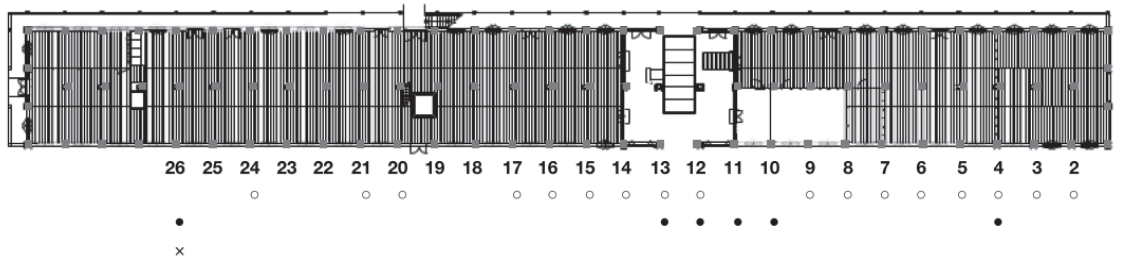
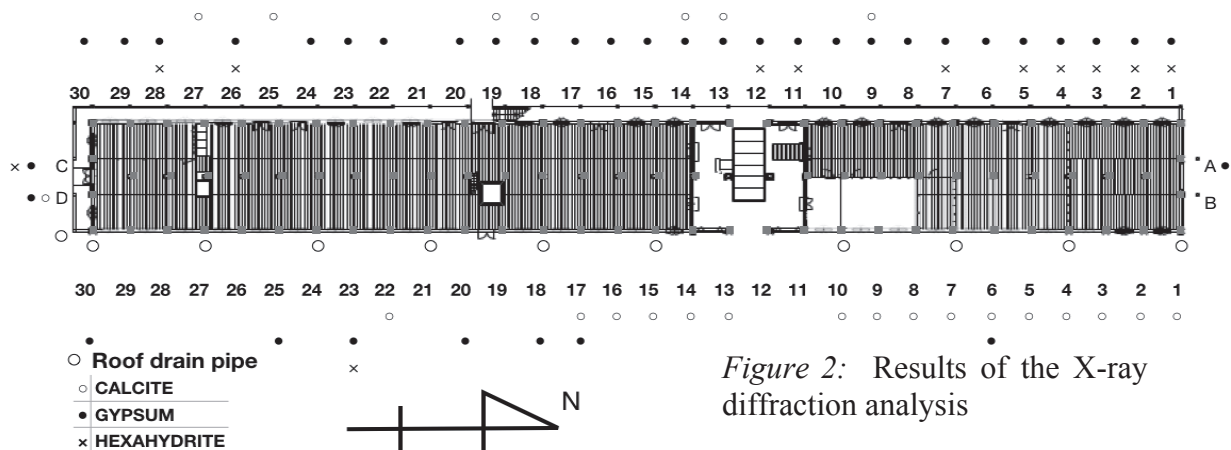
Figure 2: Results of the X-ray diffraction analysis

The results of the X-ray diffraction analysis are summarized in Fig.2. In different side of the East Cocoon Warehouse, results of the X-ray diffraction analysis appear different characteristics.

In the case of the eastern exterior side, calcite (CaCO₃) are identified in samples of No.1~10, 13~17, 22 stone pillar bases, which are mainly located at north part of the eastern exterior side. On the other hand, the stone pillar bases from which gypsum(CaSO₄ · 2H₂O) are identified, are seems neighboring roof drain pipes(No. 6, 17, 18, 20, 23, 25, 30 stone pillar bases). In the sample of No. 23, the hexahydrate is detected along with gypsum.

In the case of the western exterior side, calcites are identified in several samples collected from No. 9, 13, 14, 18, 19, 25, 27. While in most samples, gypsums are identified (except for No.21, 25, 27 stone pillar base). In samples of No. 1~5, 7, 11, 12, 26, 28 the hexahydrate are detected along with gypsum.

In the case of the northern exterior side, gypsum is identified in samples of No. A. In the case of the southern exterior side, gypsum is detected along with hexahydrate in sample of No.C, gypsum IS detected along with calcite in sample of No.D.

In the case of the interior side, calcite are identified in No. 2~9, 12~21, 24 stone pillar bases, gypsum are identified in No.4, 10~13, 26 stone pillar bases. In the sample of No. 26, the hexahydrate is detected along with gypsum.

The precipitations of calcium and magnesium sulfates appear mainly in northwestern part of the East Cocoon Warehouse.

Although stone pillar bases of exterior side of the East Cocoon Warehouse appear to be sound and intact now, some precipitations identified in this investigations implies progressing degradations.

The calcite is a typical natural component of stone, migration of calcium and recrystallization of calcite on the surface of stone can be occurred in environment with high CO₂ levels. The porous recrystallized calcite makes the penetration of salts and pollutant gases become much easier.

The pollutant gas SO₂ is mostly considered responsible for formation of gypsum. The sulphuric acid (H₂SO₄) formed by oxidized SO₂ and water, can react with calcareous materials to form calcium sulfates. Besides, the sulfates members of the MgSO₄ • nH₂O series are also highly dangerous for stone as same as calcium. The transition of CaSO₄ and CaSO₄ • 2H₂O, epsomite (MgSO₄ • 7H₂O), hexahydrate (MgSO₄ • 6H₂O) and kieserite (MgSO₄ • H₂O), are reversible and highly depending on the humidity. The recycle of “obtaining and losing extra-polyhedral water progress” may lead to size changes of sulfate crystals, which will ultimately induce micro-crack and fragile of stone.
