Post-disaster recovery linked with pre-disaster land development and damage density of Typhoon Yolanda: Toward better land-use planning in Tacloban City, the Philippines

Key Words : Slum, Subdivision, Storm surge, Resilience, Vacant lot

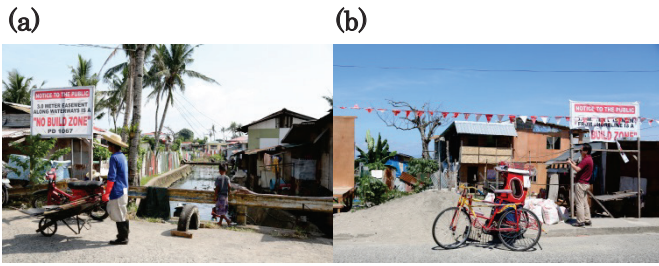
Figure 3 Photos of “NO BUILD ZONE” signs (a) beside a stream and (b) near the coast. Note that in (b), “NO” has been removed from the sign by local squatters, indicating their strong opposition to this decree. See Fig. 4 for locations of photos.

During our field survey in slum areas, we observed that “NO BUILD ZONE” signs had been erected, stating that construction of dwellings within 3 m of the river or 40 m of the shoreline was banned by Presidential Decree 1067 (Fig. 3). Nonetheless, these areas were occupied by numerous well-established squatter dwellings. We assumed that these areas were chosen by squatters because they were close to the sources of their livelihoods (e.g. fishing and caged fish farming), land prices there were low, and the “no build zone” decree was not effectively policed. Because of a lack

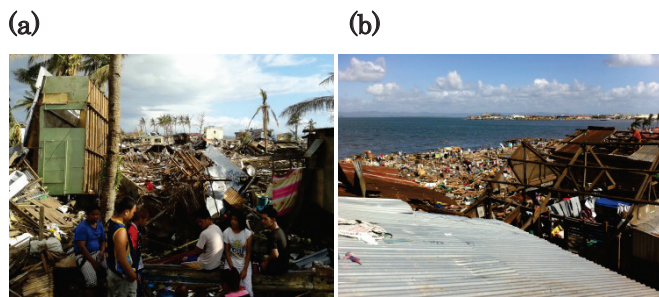
Figure 5 Resident’s photos of slum areas soon after Typhoon Yolanda (a) beside a stream (same view as in Fig. 3a) and (b) near the coast. See Fig. 4 for locations of photos.

Most of the serious damage was concentrated in slum areas along the coast and rivers on land less than 2 m asl. Photos taken by slum residents soon after Typhoon Yolanda (Fig. 5) show the extent of the damage. Watanabe *et al.* (2011) reported that many of the victims of 2009 Typhoon Ondoy lived in low-lying areas along rivers and lake shores in the central part of Luzon Island. There may be many similarly vulnerable areas in the Philippines.

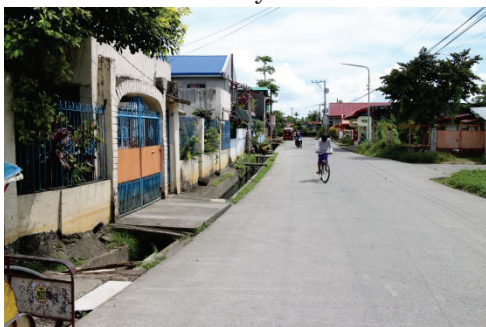
Figure 6 Photo in a developed subdivision (subdivision no. 16) showing adequate basic infrastructure (e.g. drains, electric power, and sufficiently wide paved roads)

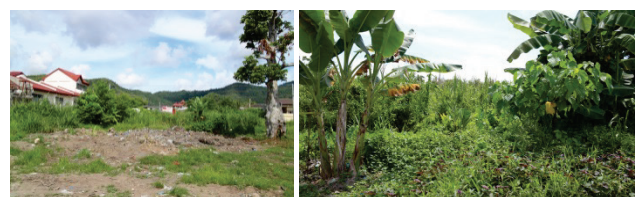
Figure 7 Examples of vegetable farming in vacant lots within subdivision no. 16

We noted a considerable number of vacant lots within the subdivisions in Tacloban City (Fig. 7), confirming the findings of Hara *et al.* (2011) who reported that vacant lots within subdivision developments were common in the Philippines, and that these lots were sometimes occupied by squatters. To avoid illegal occupation or dumping of rubbish in such lots, some absentee landlords have assigned caretakers to supervise vegetable farming in them (Hara *et al.* 2013), which was also the case in Tacloban City. During our field surveys we came across quite a few vacant lots that were being used for vegetable farming (Fig. 7).

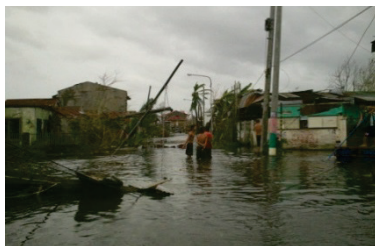
Figure 8 Resident's photo of subdivision 16 showing wind damage and flooding soon after Typhoon Yolanda

The inland locations of subdivisions 15 and 16 saved them from damage by storm surge, but there was some wind damage and serious flooding there due to the heavy rainfall (Fig. 8). These subdivisions, which are less than 4 m asl (Fig. 2 and Table 1), were flooded to a depth of about 1 m for few days because of poor drainage, but no deaths were reported.

Because roads within the subdivisions were well-constructed and wide enough for vehicular transport, large local-government-owned trucks and temporary rafts constructed from metal drums and wood (Fig. 8) were used to evacuate people and save lives. Moreover, medical clinics and temporary evacuation shelters in some of the subdivisions reduced the number of injuries and deaths. Nevertheless, as was the case in slum areas, residents felt that the available hazard maps and InSAR data were not effective in mitigating the typhoon disaster; in particular, the 1:50,000-scale storm surge hazard maps (published in 2007) did not adequately identify as hazardous much of the coastal areas that were struck by storm surge.

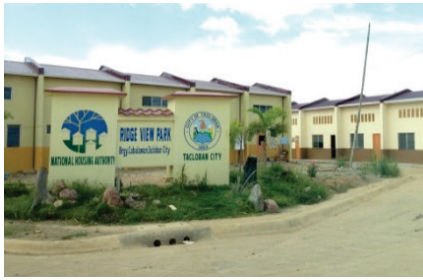
Figure 10 Example of socialized housing developed for victims of Typhoon Yolanda in Cabalawan (location shown in Fig. 9)

At the time of our field survey in May 2015, 300 of the planned 2000 dwellings in the Ridgeview Park socialized housing project in Cabalawan had been built and occupied by victims of Typhoon Yolanda (Figs. 9 and 10). Applicants for housing were required to pay 25 years of rent in advance (200 PHP per month) to gain occupancy.
