## Collapse and recovery process of the sand spit at the Tenryu River mouth on the Pacific Coast of Japan

Yoshimitsu Tajima, Tomohiro Takagawa, Shinji Sato & Satoshi Takewaka

This paper investigates the collapse and recovery processes of the sand spit at the Tenryu River mouth on the Pacific Coast of Japan, when two characteristic typhoons, Man-Yi and Fitow, passed over the study site in the year 2007. Although these two typhoons caused equally high storm waves, these two events were different in principal wave directions and in the amount of river discharges. As a result, Man-Yi collapsed the sand spit, while Fitow rather enhanced the recovery of the sand spit. Successive still images recorded by six field cameras were analyzed to investigate the dynamic morphology change of the river mouth for 2 months during which these two events had occurred. Comparisons of obtained topography changes and various hydrodynamic characteristics yielded several findings: (i) the sand spit was breached approximately 6 h after the peak of flow velocity and 2 h after the peak of the water head difference across the sand spit; (ii) the breached part of the sand spit was refilled by wave-induced shor

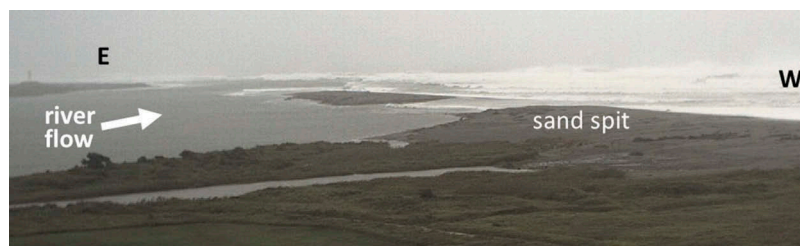
In the afternoon of the 6th, the wave height was increased more and these waves started to overtop the lower part of the sand spit. Figure 15 shows the image captured by field camera C2 at 15:00 on the 6th. In the figure, overtopping waves are observed not only at the eastern tip but also at the breached part of the sand spit. It is also seen in the bottom panel of Figure 4 that, from September 5 to 14, the land area was extended on the upstream side of the spit, both around the breached part and the eastern end of the spit where overtopping waves were observed. Based on these observations, it can be deduced that wave-induced landward sediment transport has a dominant influence on the recovery and redevelopment process of the collapsed sand spit and the upstream side of the sand spit was mainly refilled by overtopping waves.

**Figure 15.** Overtopping waves observed in the image of the camera, C2, recorded at 15:00 on September 6th.

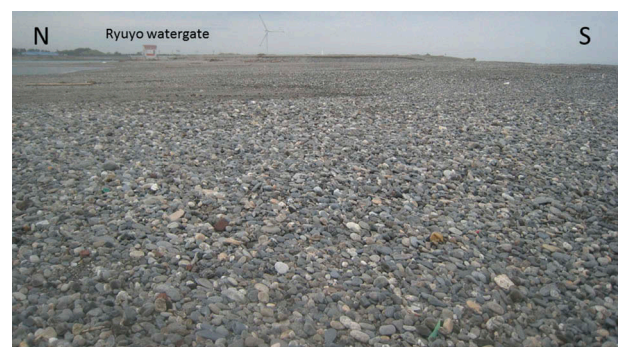
**Figure 17.** A picture taken on the breached and refilled part of the sand spit. The picture was taken on August 23 looking eastward direction.
