# Development and application of a tsunami fragility curve of the 2015 tsunami in Coquimbo, Chile

Rafael Aránguiz<sup>1,2</sup>, Luisa Urrea<sup>3</sup>, Ryo Okuwaki<sup>4</sup>, and Yuji Yagi<sup>5</sup>

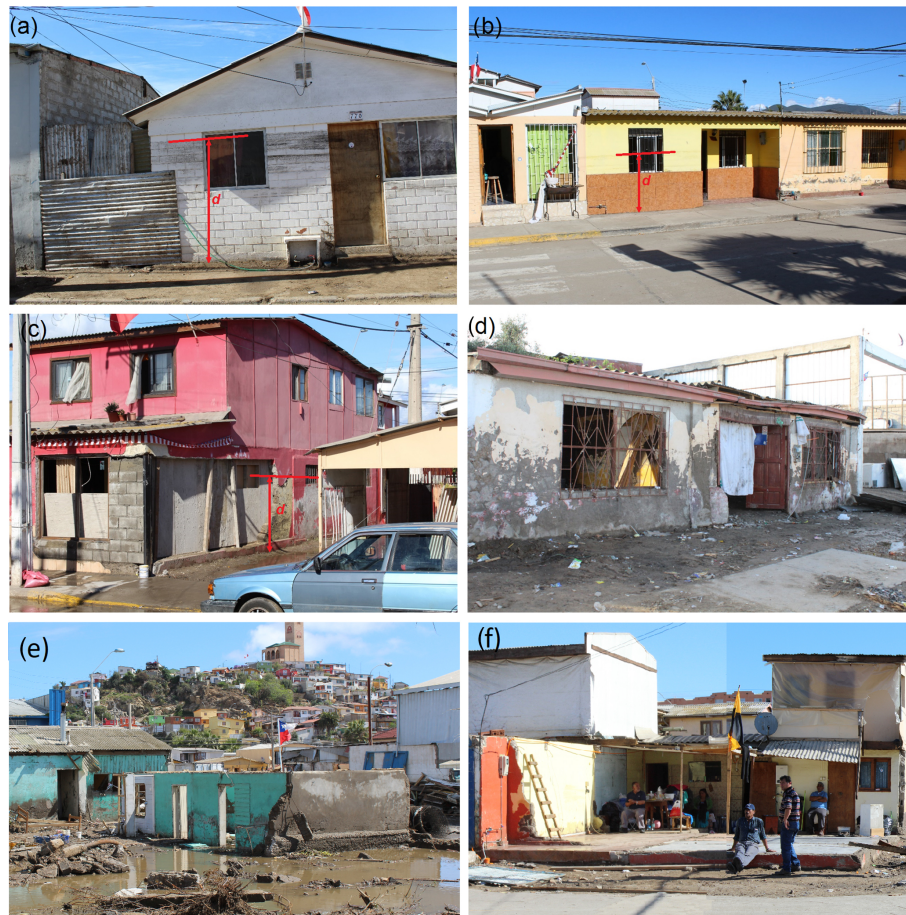
**Figure 2.** Photographs of structures undamaged and masonry houses damaged by the 16 September 2015 tsunami in the Coquimbo area. The red letter d indicates the observed tsunami inundation depth. All photos were taken on 22 September 2015.

show masonry houses that were not damaged by the tsunami despite inundation depths that ranged from 1.5 to 2 m.

Meanwhile, Fig. 2c and d show houses with moderate to major damage, ready for inhabitation again after major repairs. In fact, the house in Fig. 2c was being repaired at the time of the field survey and the gray wall in the corner had been built a few days earlier. Meanwhile, the house in Fig. 2d was abandoned since all interior walls, windows, doors and the roof were destroyed and major repairs and retrofitting would be needed. Figure 2e shows a destroyed structure with its interior walls and roof completely removed, while Fig. 2f shows the remaining foundation of a washed-away structure. Even though the damage to the structure could be due to both the earthquake and tsunami, it was observed that damage due to the earthquake was limited (Candia et al., 2017) and the structures most affected by the earthquake were made of adobe (Fernández et al., 2017). In addition, the authors had the opportunity to compare damage to inundated and non-inundated houses in Coquimbo in order to verify that the structural damage to inundated houses was due to the tsunami. In order to avoid categorizing light damage (due to

In addition, the two-level damage scale was used due to the small number of inundated structures (568) and for comparison with the existing fragility curve of Dichato (Mas et al., 2012), which has only two damage levels. The first level, called “not destroyed,” included structures with no damage or minor to major damage, corresponding to levels 1–3 given by Suppasri et al. (2013). These damage levels indicate that there is slight to severe damage to nonstructural components; therefore, it would be possible to use the structures after moderate to major repairs (Fig. 2a–c). The other damage level, called “destroyed,” included damage levels 4 to 6 according to Suppasri et al. (2013), i.e., structures that underwent severe damage to walls or columns or that had completely collapsed (Fig. 2d–f).

Okushiri, Banda Aceh, American Samoa and Thailand. It is seen that Coquimbo experienced less damage than Dichato and Okushiri at inundation depths lower than 3 m. In fact, at an inundation depth of 2 m, Dichato and Okushiri have a 68 %–75 % probability of damage, while in Coquimbo the probability is only 20 %. The high probability of damage in Dichato and Okushiri could be due to the large number of structures made of wood and lightweight materials with little ability to withstand tsunami flows (Mas et al., 2012). Even though the building materials in Coquimbo are similar, it is observed in Fig. 7b that distance from the shore and the railway embankment decrease flow velocity and thus tsunami energy; therefore, the same inundation depth generates less damage to structures. In a similar manner, the fragility curve for mixed-material structures in Thailand shows a high probability of damage at an inundation depth of 2 m (~ 50 %), but a 100 % probability of damage is reached at inundation depths higher than 8 m. In the case of Banda Aceh, the curve shows a low probability of damage (< 20 %) at an inundation depth of 2 m, which is comparable to Coquimbo; however, the damage probability in Coquimbo increases rapidly as the inundation depth increases, reaching 100 % at an inundation depth of only 4 m, which could be a result of most of the houses having only one or two stories (see Fig. 2).
